SHOP PROCEDURES - MECHANICAL TESTS
ELECTRONIC SECRETARY [®] MODEL SP-2

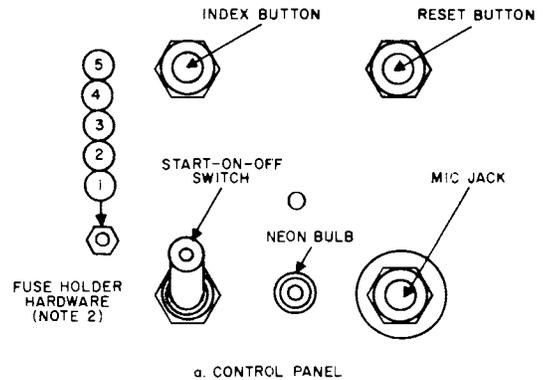
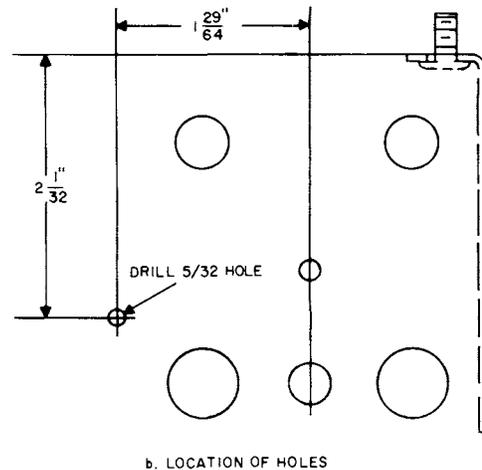
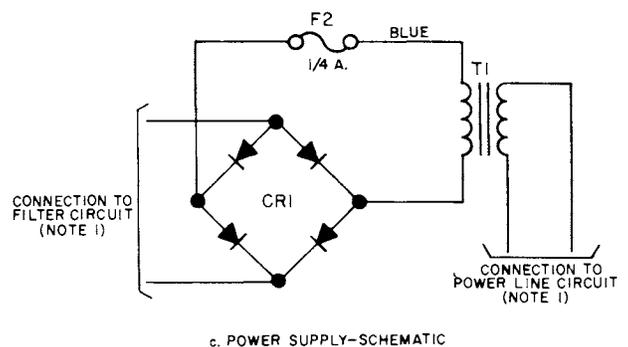
Figure 4. Fuse Modification.

6.01 A high incidence of power transformer failure has occurred in those Model SP-2 telephone answering sets with chassis serial numbers below 41300. It is theorized that this difficulty is due to an inferior lot of rectifier stacks or filter capacitors.

6.02 This difficulty has been reduced to minimum by adding a fuse in the transformer secondary circuit. (All units with chassis serial number 41300 or higher now contain this fuse.) Addition of this fuse to the units in the field can be accomplished with a simple modification. Parts for this modification are contained in a conversion kit, available upon request and furnished on a no-charge basis.

- (9) On the amplifier chassis, locate, mark, and drill a hole $5/32''$ in diameter for the fuseholder at the position shown in Figure 4. Install fuseholder and mounting hardware.

- (10) Connect the fuseholder as shown in the schematic portion of Figure 4. Install $1/4$ amp fuse.
 - (11) Reassemble the Model SP-2.
- NOTE: Prior to reinstalling the message indicator arm, manually depress the armature of the reset magnet and ensure that the tone arm returns to its starting or number 1 position. Then, reinstall the message indicator arm and check that it does not rub against its slot in the cabinet.
